**AUTOMATIC INSPECTION, DIAGNOSTIC AND PROGNOSTIC
SYSTEM (AIDAPS), TEST CELL DATA COLLECTION AND
TECHNICAL SUPPORT**

J. V. HICKEY

AUGUST 1977

FINAL REPORT

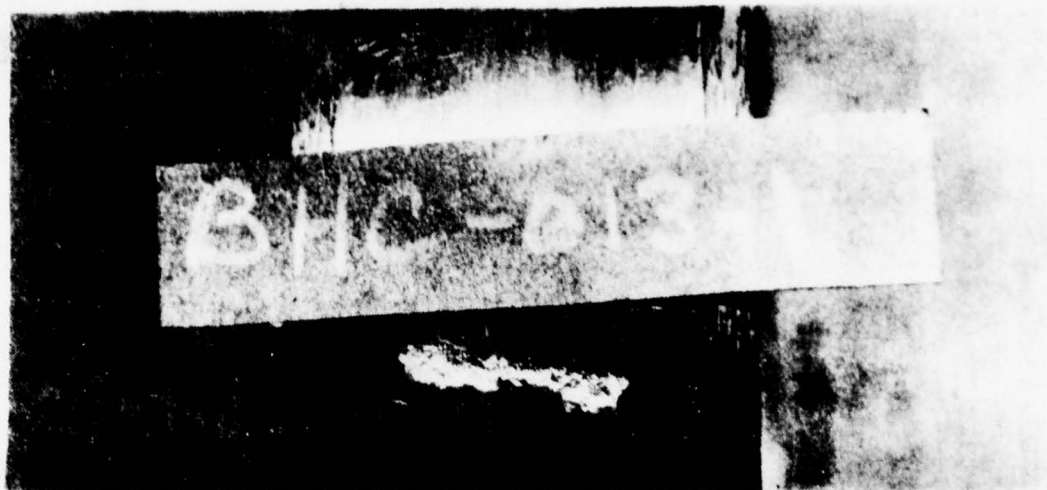
Figure E-13
Implant BHC-013
Roller Bearing P/N 204-040-310, S/N H1660
Artificial Category "C" Inner Race Spall

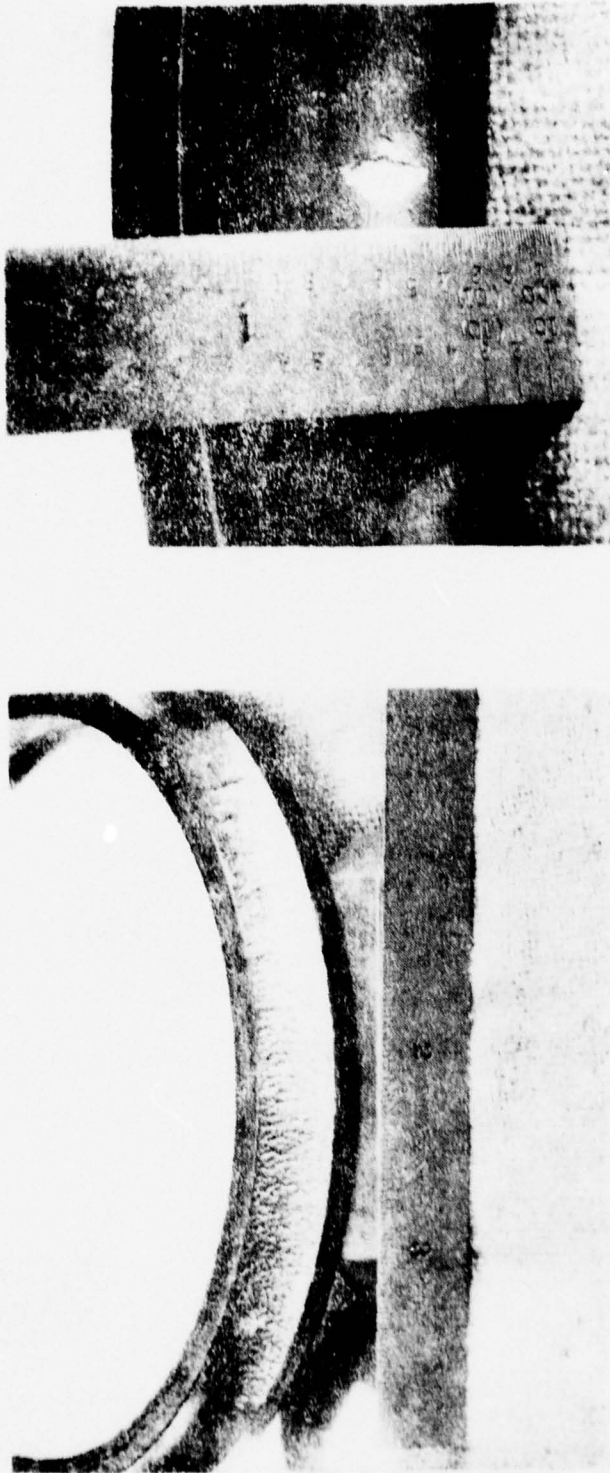
Figure E-51
Implant BHC-052
Ball Bearing P/N 204-040-136, S/N 1919X
Natural Category "D" Inner And Outer Race Spalls

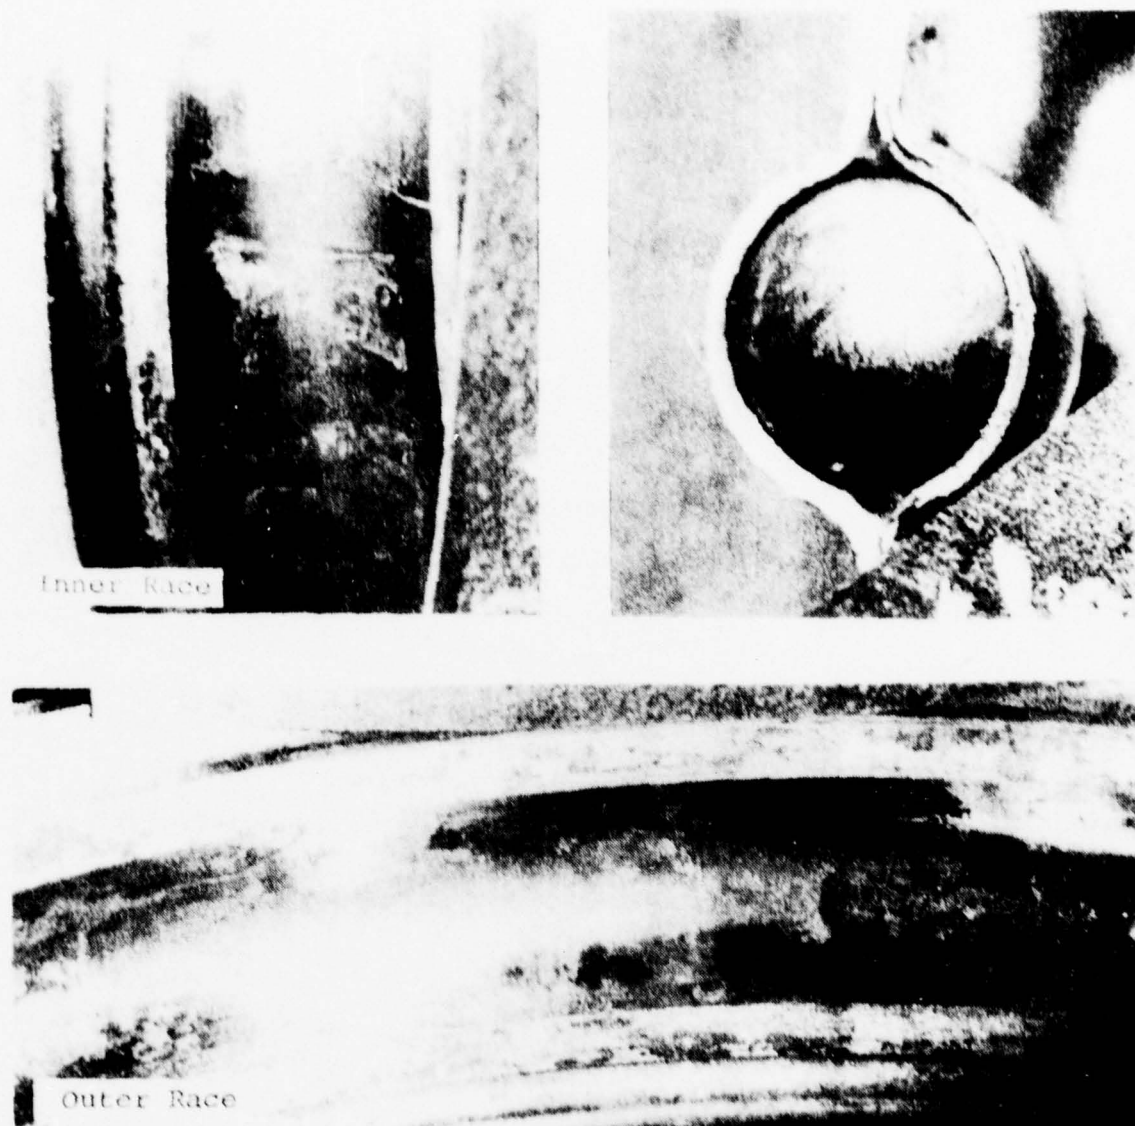
Figure E-55
Implant BHC-056
Hanger Bearing P/N 204-040-623
Natural Category "D" Inner Race, Outer Race, and Ball Spalls
